**Flood Control Project Maintenance
Levee Inspections**
LMA District Cover Sheet
Spring 2018 Levee Inspection Results

Levee District No. 0001 (Glenn County)

Spring 2018 Levee Inspection Results

Waterway			Bank	Unit Miles
Unit No. 01 Sacramento River			Right	12.23
	Spring (March - May)	Summer (June - August)	(September - November) Fall	Winter (December - February)
Unit Maintenance Rating (Fall Only)				
Date of Inspection	3/8/2018 - 3/8/2018			
DWR Inspector	Bob Duffey			
Accompanied By	Jason Enos LD1G

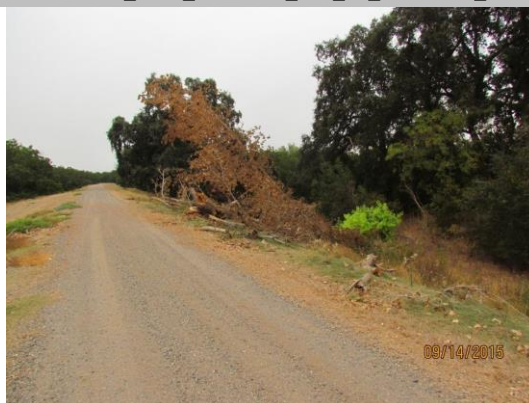
Photo 1 of 2 : SP_2018_LD0001G_432_41_20180305_00011.jpg

View of the tree on the waterside slope.

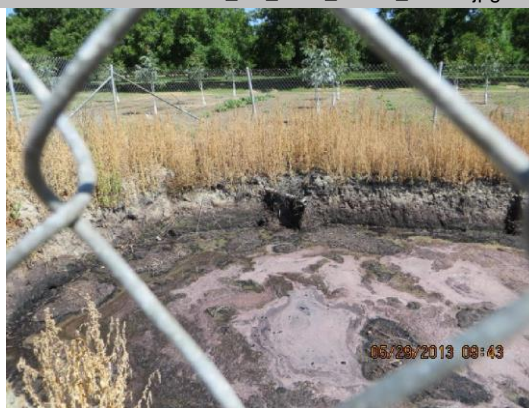
Photo 1 of 3 : UCIP_SP_2018_14324_23564.jpg

LM Start	0.77	Rating **	M	Issue No.	396
LM End	0.77	Issue Type +	En	Location *	
Category	Supplemental			GPS Latitude/Longitude	
				Start	End
Item	DWR UCIP Field Study			39.487806 °	39.487806 °
				-122.019414 °	-122.019414 °
DWR ID					
Comment Code					
Inspector Comment					
FS_ID:14324 DS_ID:22893 EP_NO: 11782 Repair Type: Non-Urgent Crossing Status: Found UCIP Comments: 5/29/2013 - Siphon breaker missing from WS shoulder (W. Wylie - DWR UCIP) FIELD_STRUCT_DESC: 3-inch galvanized steel water pipe through the levee, 2 feet below the crown. There is a hose bib style siphon breaker on the waterside (WS) shoulder. A pipe runs from the concrete sump next to the barn on the landside (LS) to a cesspool off of the WS toe. (Permit No. 11782, 1976 - Carriere Brothers). [Additional Reference(s): DWR Levee Log, 1992]. FS Date: 5/29/2013

3-inch pipe at cesspool off WS toe.

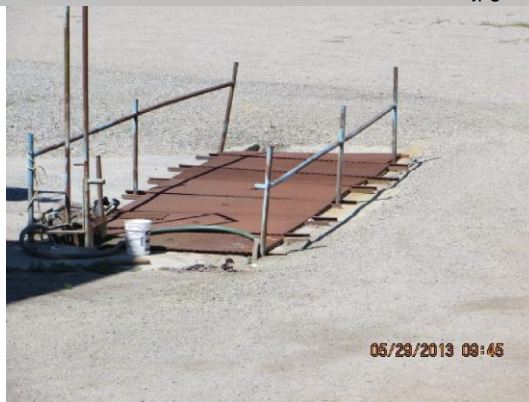
Photo 3 of 3 : UCIP_SP_2018_14324_23562.jpg

LM Start	0.77	Rating **	M	Issue No.	396 (cont)	
LM End	0.77	Issue Type +	En	Location *		
Category	Supplemental			GPS Latitude/Longitude		
				Start		End
Item	DWR UCIP Field Study			39.487806 °	39.487806 °	
				-122.019414 °	-122.019414 °	
DWR ID						
Comment Code						
Inspector Comment						
FS_ID:14324 DS_ID:22893 EP_NO: 11782 Repair Type: Non-Urgent Crossing Status: Found UCIP Comments: 5/29/2013 - Siphon breaker missing from WS shoulder (W. Wylie - DWR UCIP) FIELD_STRUCT_DESC: 3-inch galvanized steel water pipe through the levee, 2 feet below the crown. There is a hose bib style siphon breaker on the waterside (WS) shoulder. A pipe runs from the concrete sump next to the barn on the landside (LS) to a cesspool off of the WS toe. (Permit No. 11782, 1976 - Carriere Brothers). [Additional Reference(s): DWR Levee Log, 1992]. FS Date: 5/29/2013

Concrete sump next to barn off LS toe.

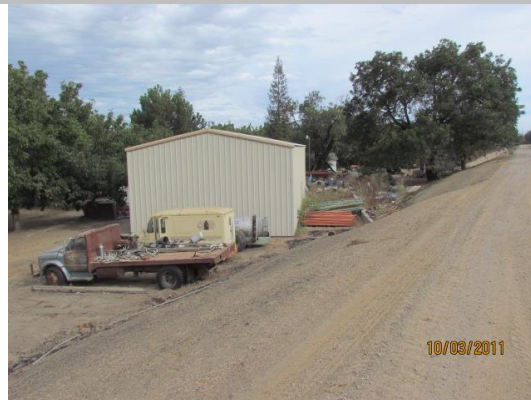
Photo 1 of 1 : SP_2018_LD0001G_432_74_20180305_00037.jpg

LM Start	1.09	Rating **	M	Issue No.	398	
LM End	1.09	Issue Type +	En	Location *		
Category	Supplemental			GPS Latitude/Longitude		
				Start	End	
Item	DWR UCIP Field Study			39.492090 °	39.492090 °	
				-122.020014 °	-122.020014 °	
DWR ID						
Comment Code						
Inspector Comment						
FS_ID:14326						
DS_ID:22895						
EP_NO: 2171						
Repair Type: Non-Urgent						
Crossing Status: Not Found						
UCIP Comments: Need to determine disposition of this pipe.						
FIELD_STRUCT_DESC: 1 of 2: 3-inch gas pipeline of an unknown material through the levee, 2 feet below the crown. (Permit No. 2171, 1955 - Sunray Mid-Continent Oil Company). [Additional Reference(s): DWR Levee Log, 1992].						
FS Date: 5/29/2013

View of vehicles & equipment along the L/S toe.

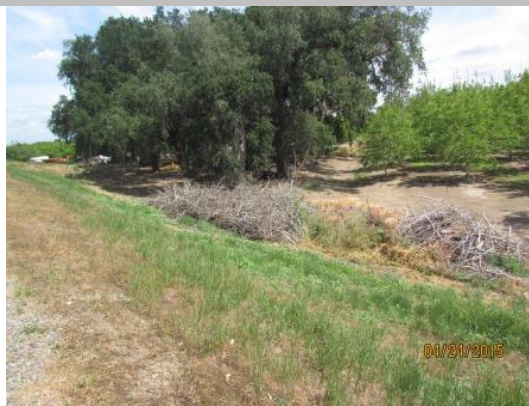
Photo 1 of 1 : SP_2018_LD0001G_432_58_20180305_00025.jpg

View of the prunings along the waterside toe.

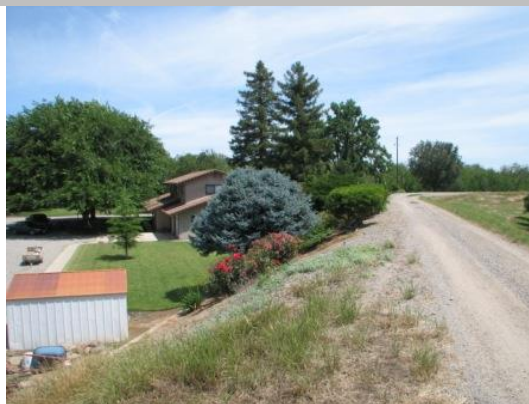
Photo 1 of 1 : SP_2018_LD0001G_432_6_20180305_00002.jpg

LM Start	1.32	Rating **	A/W	Issue No.	6
LM End	1.36	Issue Type +	En	Location *	LS
Category	Earthen Levee			GPS Latitude/Longitude	
				Start	End
Item	Vegetation			39.494828 °	39.495330 °
				-122.017632 °	-122.017163 °
DWR ID	DWR_LD0001G_01_s_2012_6				
Comment Code					
V6 : Landscaping					
Inspector Comment					
Landscaping Permit No. 13057

View of the permitted landscape on the landside slope of the levee.

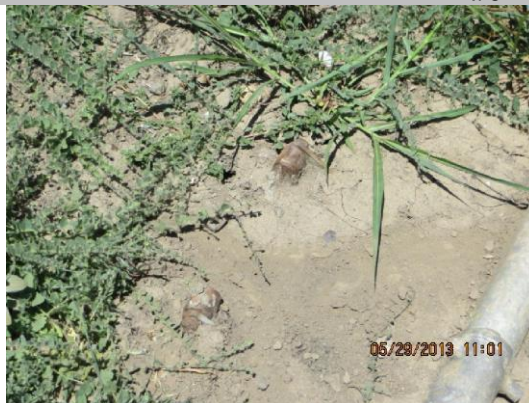
Photo 1 of 2 : UCIP_SP_2018_16223_27343.jpg

LM Start	3.13	Rating **	M	Issue No.	403	
LM End	3.13	Issue Type +	En	Location *		
Category	Supplemental			GPS Latitude/Longitude		
				Start		End
Item	DWR UCIP Field Study			39.513835 °		39.513835 °
				-122.010029 °		-122.010029 °
DWR ID						
Comment Code						
Inspector Comment						
FS_ID:16223 DS_ID:22901 EP_NO: 9575 Repair Type: Non-Urgent Crossing Status: Found UCIP Comments: Appears to have been abandoned. Need to verify pipe was grouted/abandoned properly. FIELD_STRUCT_DESC: *ABANDONED* 12-inch drainage pipe of an unknown material through the levee, 14 feet below the crown. Flap Gate on the waterside (WS) end. (Automatic Board Order (ABO) issued as Permit No. 9575, 1974 - Franklin Emmett, Bette Lou Dillard Jr., and McIntyre). [Additional Reference(s): DWR Levee Log, 1992]. FS Date: 5/29/2013

Flap gate visible at WS toe.

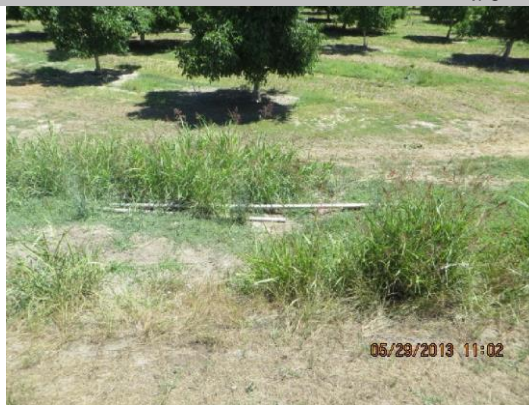
Photo 2 of 2 : UCIP_SP_2018_16223_27342.jpg

Flap gate visible at WS toe.

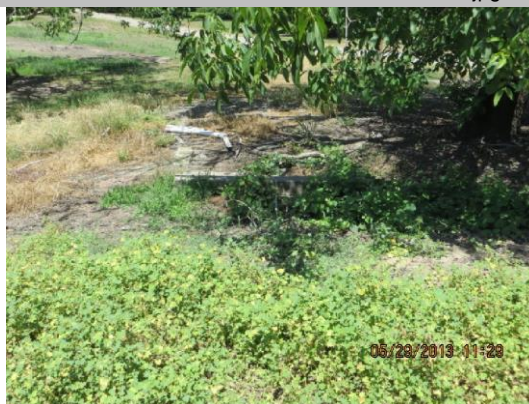
Photo 2 of 3 : UCIP_SP_2018_51463_27385.jpg

Comment Code					
Inspector Comment					
FS_ID:51463 DS_ID:22904 EP_NO: 9572 Repair Type: Urgent Crossing Status: Found UCIP Comments: 12/21/2016 Flap gate on WS does not appear to be broken however, flap gate does not fully close due to a 3-inch aluminum pipe sleeve through larger pipe. Need to remove 3-inch pipe in order to have WS flap gate close and to be compliant with Title 23. (O. Magana - DWR UCIP)05/29/2013 Broken flap gate and Concrete headwall on LS toe possibly tilting. Also a 3-inch alluminum irrigation line through the pipe. (W. Wylie - DWR UCIP) FIELD_STRUCT_DESC: 18-inch steel drainage pipe through the levee, 7.3 feet below the crown. Flap gate in 6-inch by 6-inch concrete box located on the waterside (WS) end. Concrete headwall located on the landside (LS) toe. (18-inch pipe [HLM 4.05] authorized under Automatic Board Order (ABO) issued as Permit No. 9572, 1974 - Henry and Annabel B. Smith). [Additional Reference(s): DWR Levee Log, 1992. USACE Sacramento O&M Manual 140, May 1960, (HLM 4.05)]. FS Date: 12/21/2016

Headwall on LS toe.

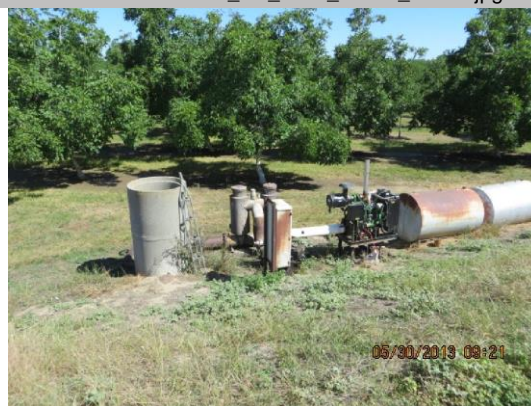
Photo 1 of 3 : UCIP_SP_2018_51284_23594.jpg

Comment Code					
Inspector Comment					
FS_ID:51284 DS_ID:22906 EP_NO: 1229 Repair Type: Non-Urgent Crossing Status: Found UCIP Comments: 12/21/2016 same as last inspection. Crossing has been modified from original permit. Need to contact owner to determine permit number issued for modification and to determine current status of crossing. Crossing has been downgraded from Urgent to Non-Urgent due to no damage observed on levee slopes or crown. (O. Magana - DWR UCIP)05/30/2013 Gate valve broken off in concrete standpipe on WS shoulder. 8-inch aluminum pipe sleeved through pipe prevents closure of 18-inch pipe. All concrete standpipes have been modified or broken. (W. Wylie - DWR UCIP) FIELD_STRUCT_DESC: 16-inch concrete (not 18-inch asphalt dipped steel as referenced in permit or USACE O&M manual) irrigation pipe through the levee, 8.6 feet below the crown. Gate valve in concrete well located on the waterside (WS) slope. Pump, service pole, engine, and fuel tank 48-inch, and standpipe are located on the toe of the landside (LS) slope (Permit No. 1229, 1947 - R. T. Miller). [Additional Reference(s): DWR Levee Log, 1992. USACE Sacramento O&M Manual Unit 140, May 1960, (HLM 4.33)]. FS Date: 12/21/2016

Pump, standpipe, and gate valve on LS toe.

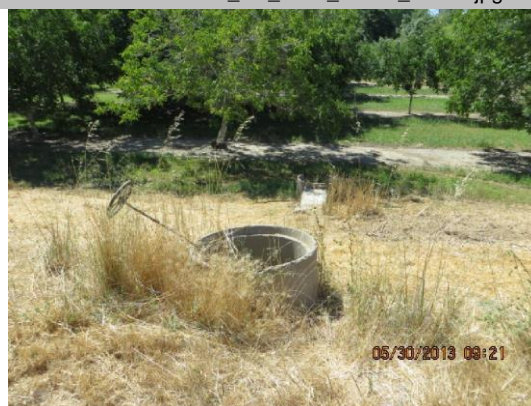
Photo 2 of 3 : UCIP_SP_2018_51284_23593.jpg

Gate valve in Concrete riser on WSs houlder.

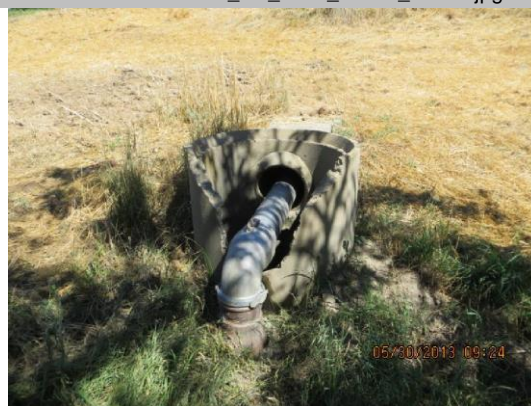
Photo 3 of 3 : UCIP_SP_2018_51284_23592.jpg

Comment Code						
Inspector Comment						
FS_ID:51284 DS_ID:22906 EP_NO: 1229 Repair Type: Non-Urgent Crossing Status: Found UCIP Comments: 12/21/2016 same as last inspection. Crossing has been modified from original permit. Need to contact owner to determine permit number issued for modification and to determine current status of crossing. Crossing has been downgraded from Urgent to Non-Urgent due to no damage observed on levee slopes or crown. (O. Magana - DWR UCIP)05/30/2013 Gate valve broken off in concrete standpipe on WS shoulder. 8-inch aluminum pipe sleeved through pipe prevents closure of 18-inch pipe. All concrete standpipes have been modified or broken. (W. Wylie - DWR UCIP) FIELD_STRUCT_DESC: 16-inch concrete (not 18-inch asphalt dipped steel as referenced in permit or USACE O&M manual) irrigation pipe through the levee, 8.6 feet below the crown. Gate valve in concrete well located on the waterside (WS) slope. Pump, service pole, engine, and fuel tank 48-inch, and standpipe are located on the toe of the landside (LS) slope (Permit No. 1229, 1947 - R. T. Miller). [Additional Reference(s): DWR Levee Log, 1992. USACE Sacramento O&M Manual Unit 140, May 1960, (HLM 4.33)]. FS Date: 12/21/2016

8-inch pipe sleeved through 16-inch pipe at LS toe.

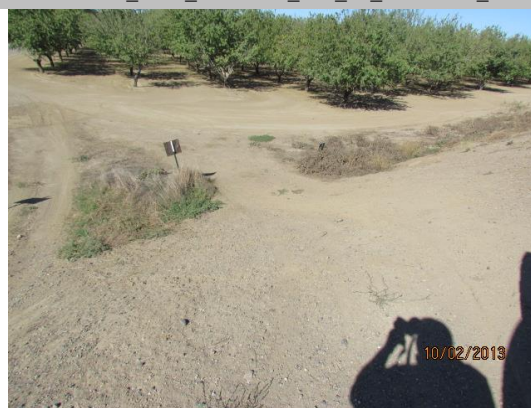
Photo 1 of 1 : SP_2018_LD0001G_432_57_20180305_00024.jpg

LM Start	5.06	Rating **	M	Issue No.	57
LM End	5.06	Issue Type +	Ma	Location *	LS
Category	Earthen Levee			GPS Latitude/Longitude	
				Start	End
Item	Slope Stability			39.534593 °	39.534593 °
				-121.995950 °	-121.995950 °
DWR ID	DWR_LD0001G_01_f_2013_57				
Comment Code					
S3 : Repair the levee slope damaged by vehicle traffic and prevent access where possible.					
Inspector Comment

View of the vehicle erosion along the slope of the levee.

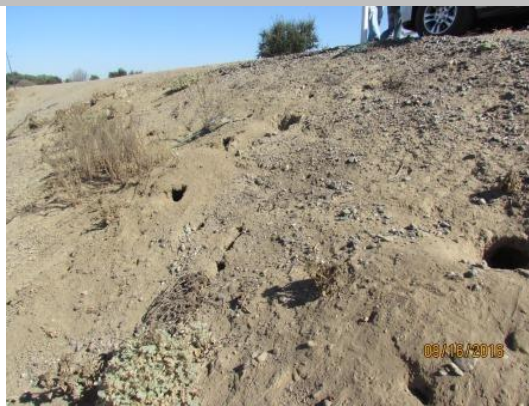
Photo 1 of 1 : SP_2018_LD0001G_432_67_20180305_00033.jpg

View of the rodent holes along the landside slope.

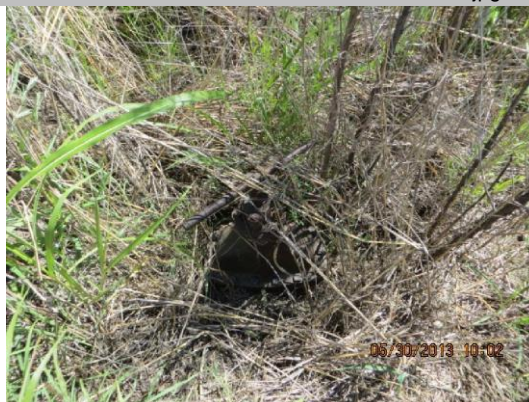
Photo 2 of 3 : UCIP_SP_2018_14346_23600.jpg

Gate valve on WS toe.

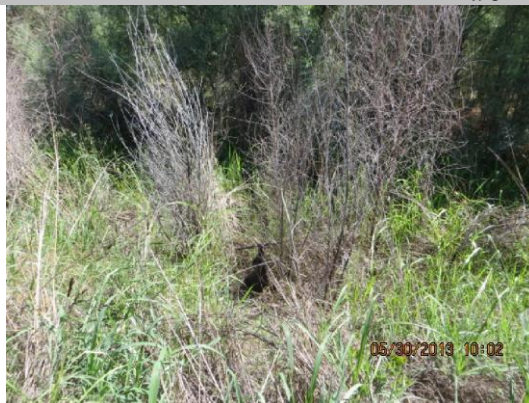
Photo 3 of 3 : UCIP_SP_2018_14346_23599.jpg

Item	DWR UCIP LMA Responsibility			39.540546 °	39.540546 °	
				-121.998981 °	-121.998981 °	
DWR ID						
Comment Code						
Inspector Comment						
FS_ID:14346						
DS_ID:22907						
EP_NO: 344						
Repair Type: No Action Needed						
Crossing Status: Found						
UCIP Comments:						
FIELD_STRUCT_DESC: 12-inch drainage pipe of an unknown material through the levee, 6.5 feet below the crown. Gate valve at the waterside (WS) toe. Air vent and pump at the landside (LS) toe. (Automatic Board Order (ABO) issued as Permit No. 9566, 1974 - B. and M. Giesbrecht). (Permit No. 344, Date Unknown - Alameda Sugar). [Additional Reference(s): DWR Levee Log, 1992. USACE Sacramento O&M Manual 140, May 1960, (HLM 5.61)].						
FS Date: 5/30/2013

Gate valve on WS toe.

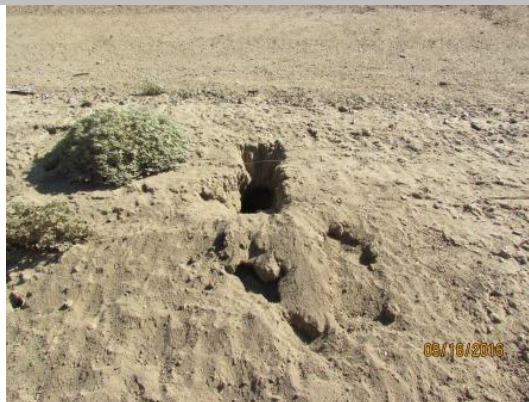
Photo 1 of 1 : SP_2018_LD0001G_432_75_20180305_00038.jpg

View of the rodent holes along the landside slope.

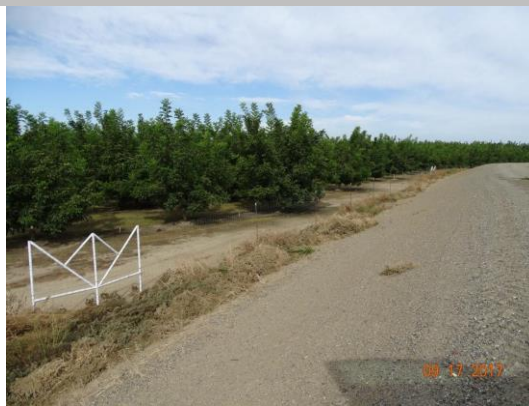
Photo 1 of 1 : SP_2018_LD0001G_432_78_20180305_00040.jpg

View of the fence along the landside toe.

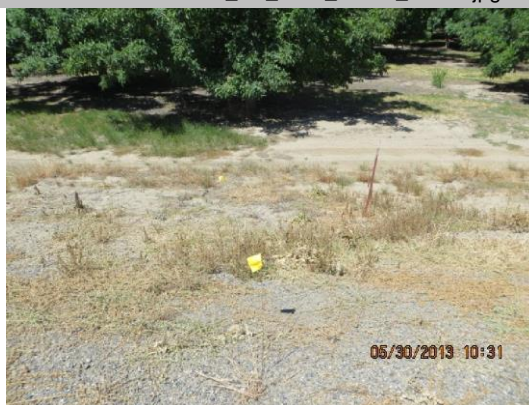
Photo 1 of 2 : UCIP_SP_2018_14352_23609.jpg

Gasline flags on LS slope.

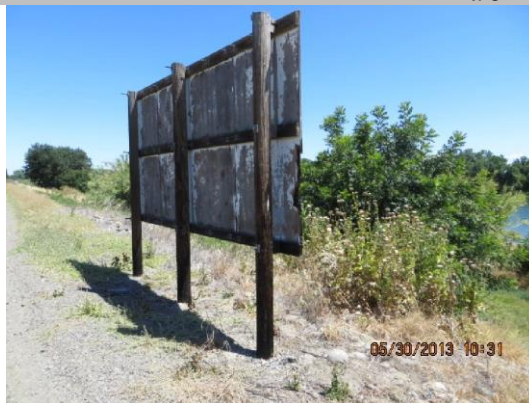
Photo 2 of 2 : UCIP_SP_2018_14352_23608.jpg

Gasline sign on WS shoulder.

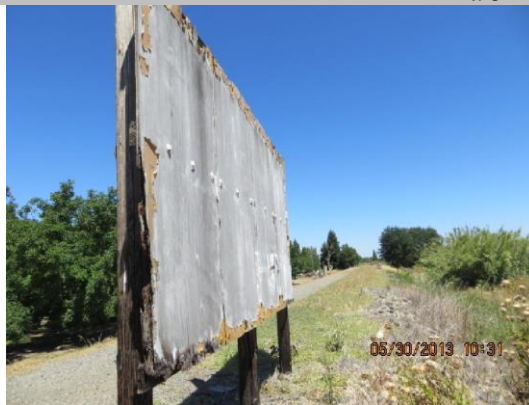
Photo 1 of 1 : UCIP_SP_2018_16224_27345.jpg

Gasline sign on WS shoulder.

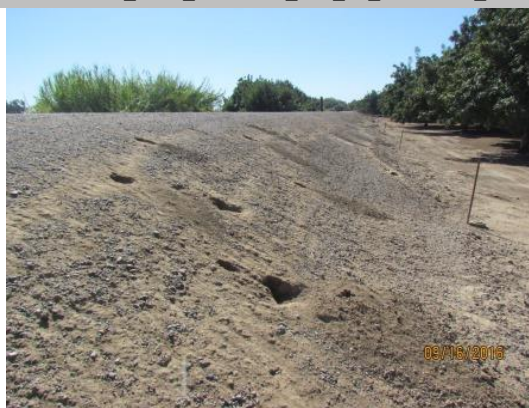
Photo 1 of 1 : SP_2018_LD0001G_432_76_20180305_00039.jpg

View of the rodent holes along the landside slope.

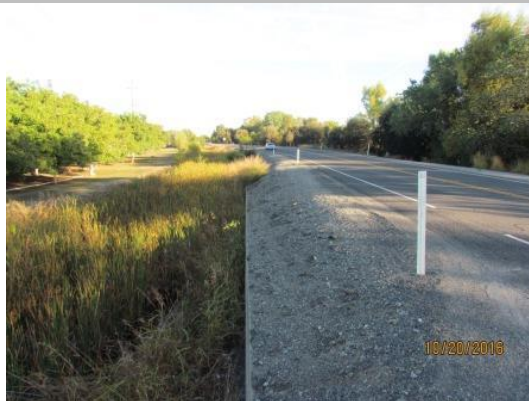
Photo 1 of 2 : SP_2018_LD0001G_432_69_20180305_00034.jpg

Another view of the ag ditch looking upstream.

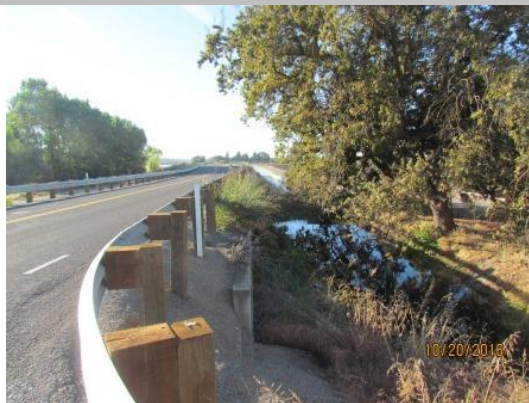
Photo 2 of 2 : SP_2018_LD0001G_432_69_20180305_00035.jpg

View of the ag ditch looking downstream.

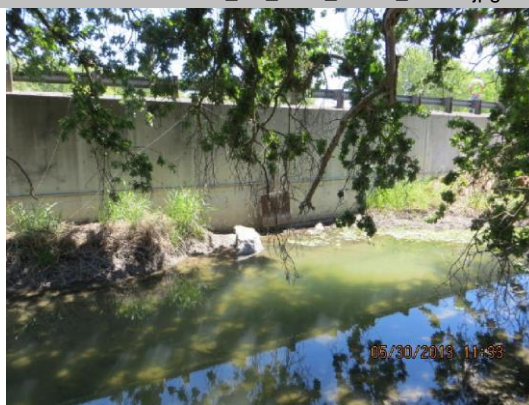
Photo 1 of 2 : UCIP_SP_2018_14373_23655.jpg

Pipe with steel plate welded over end on LS of levee crown.

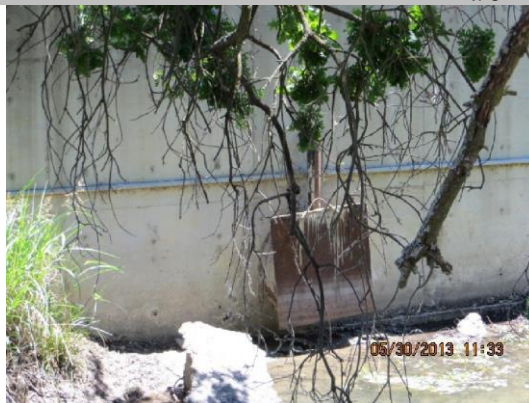
Photo 2 of 2 : UCIP_SP_2018_14373_23654.jpg

Pipe with steel plate welded over end on LS of levee crown.

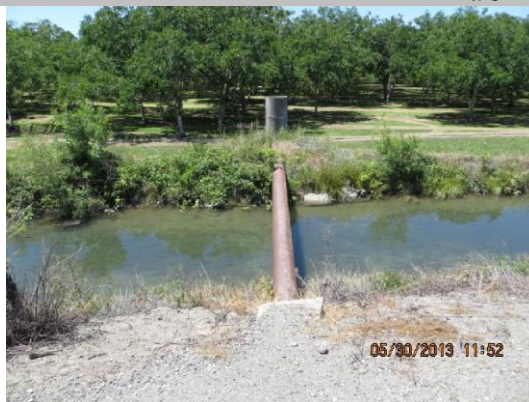
Photo 1 of 3 : UCIP_SP_2018_14384_23664.jpg

Pipe on LS toe with concrete standpipe visible.

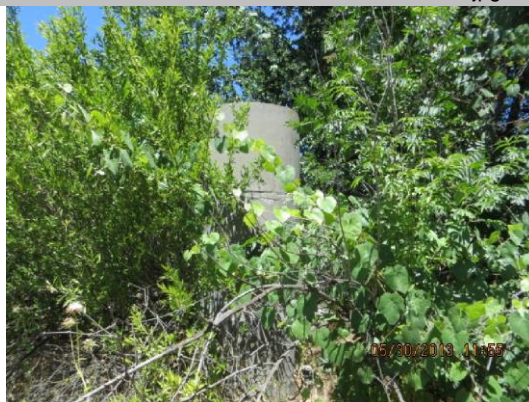
Photo 3 of 3 : UCIP_SP_2018_14384_23662.jpg

Concrete standpipe off WS toe.

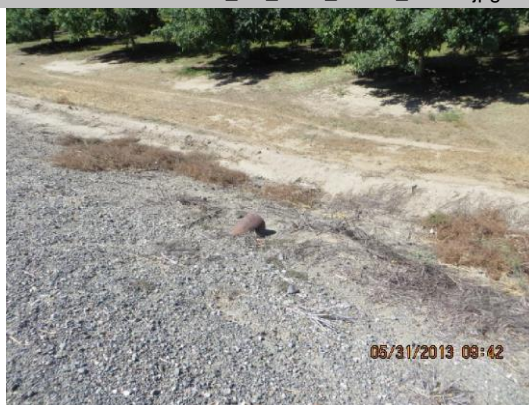
Photo 1 of 3 : UCIP_SP_2018_51285_23668.jpg

Pipe on LS slope.

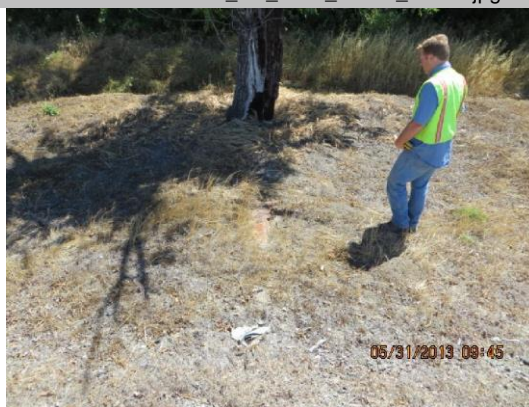
Photo 3 of 3 : UCIP_SP_2018_51285_23666.jpg

Pipe on WS slope.

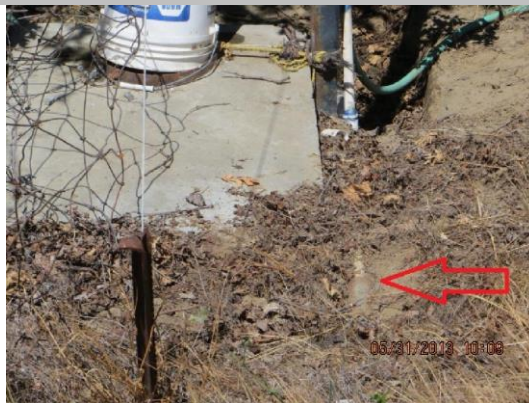
Photo 2 of 3 : UCIP_SP_2018_16204_27329.jpg

Pipe visible next to well with bucket over standpipe.

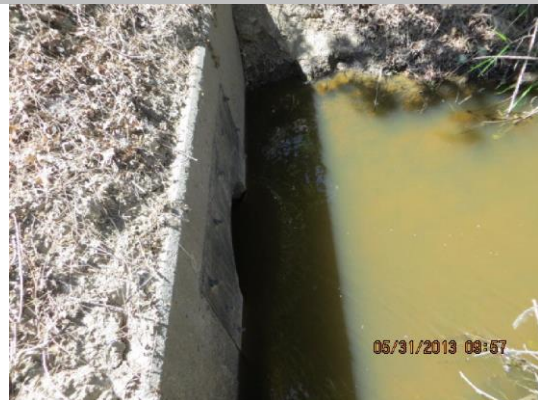
Photo 1 of 3 : UCIP_SP_2018_16226_27356.jpg

Concrete headwall on LS toe.

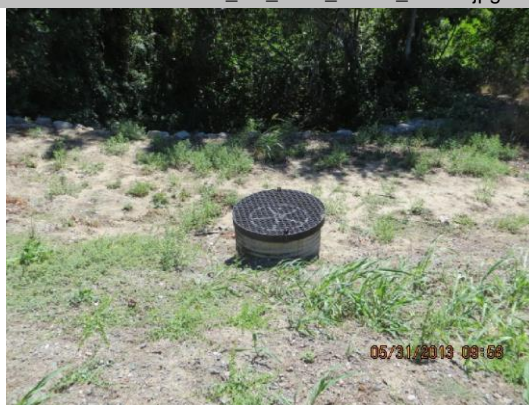
Photo 3 of 3 : UCIP_SP_2018_16226_27354.jpg

Slide gate in 44-inch CMP riser on WS slope.

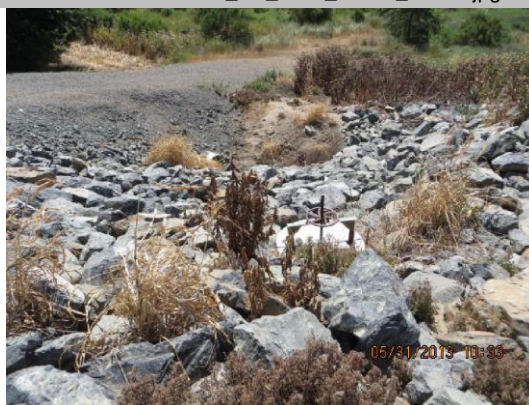
Photo 1 of 3 : UCIP_SP_2018_14390_23690.jpg

Slide gate in 36-inch CMP riser on WS slope.

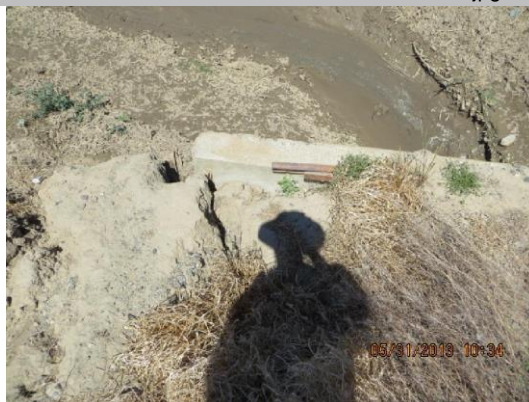
Photo 3 of 3 : UCIP_SP_2018_14390_23688.jpg

Erosion around headwall at LS toe.

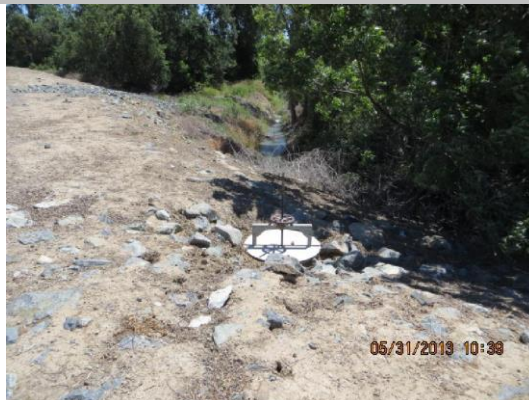
Photo 2 of 3 : UCIP_SP_2018_14559_23985.jpg

Slide gate in 36-inch CMP riser on WS slope.

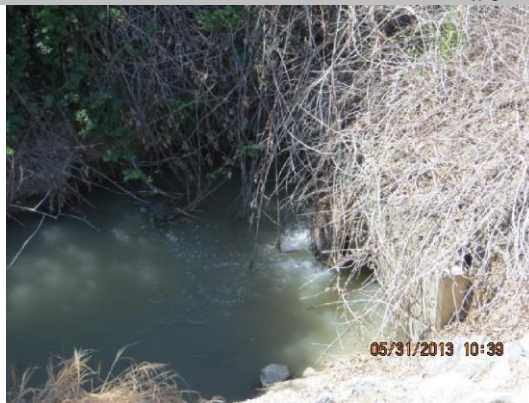
Photo 3 of 3 : UCIP_SP_2018_14559_23984.jpg

Pipe, flapgate, and headwall on WS toe.

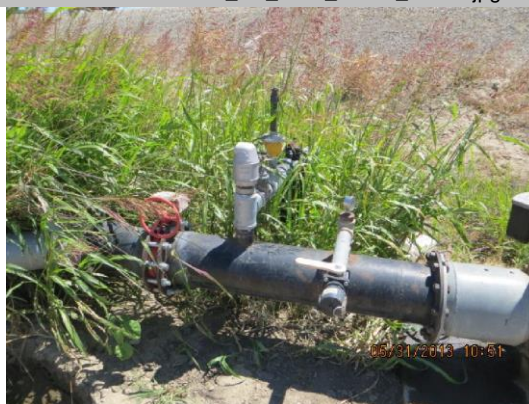
Photo 1 of 3 : UCIP_SP_2018_16205_27333.jpg

Pump with siphon breaker, vent and filter on LS toe.

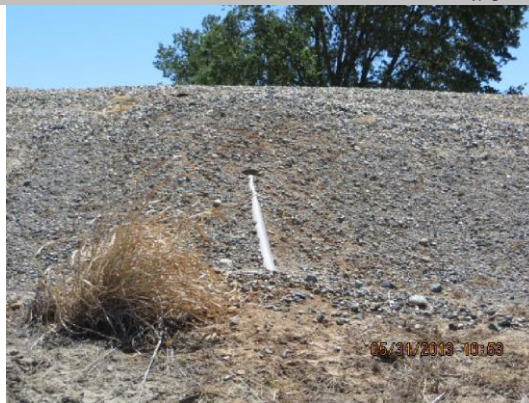
Photo 2 of 3 : UCIP_SP_2018_16205_27332.jpg

Pipe on LS slope.

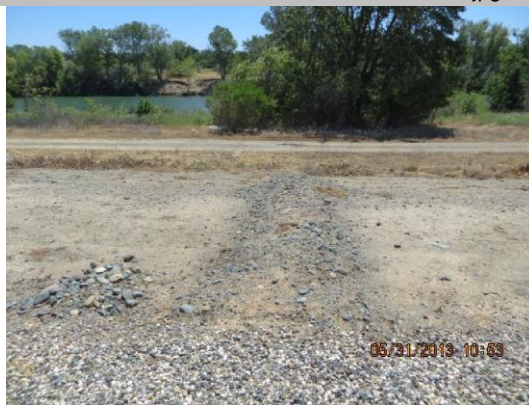
Photo 3 of 3 : UCIP_SP_2018_16205_27331.jpg

Cover over pipe on WS berm.

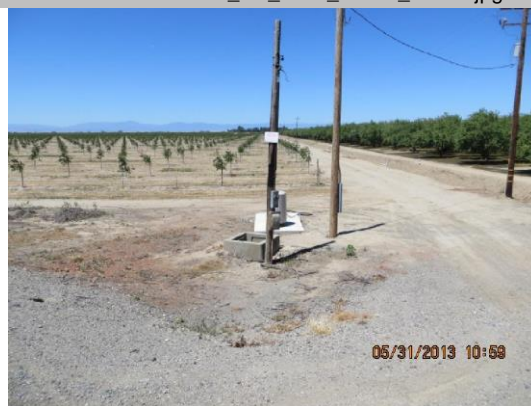
Photo 1 of 3 : UCIP_SP_2018_14561_23989.jpg

Concrete distribution box at LS toe.

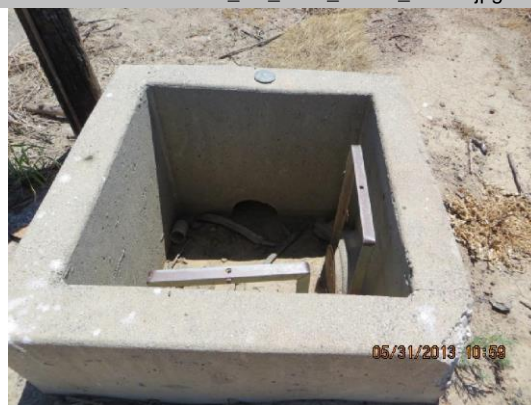
Photo 2 of 3 : UCIP_SP_2018_14561_23988.jpg

Concrete distribution box at LS toe with outlet from pipe through levee.

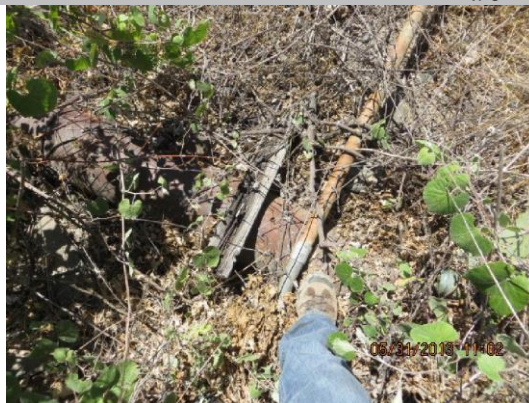
Photo 2 of 2 : UCIP_SP_2018_14562_23990.jpg

Pipe visible off WS toe.

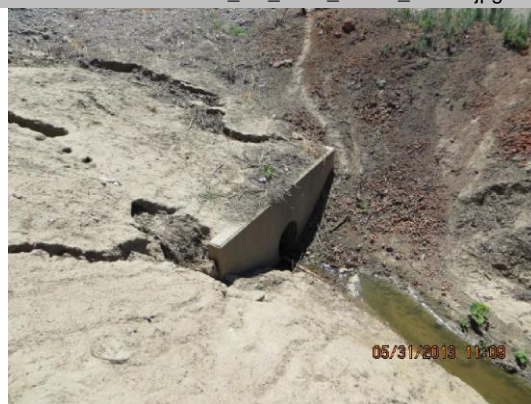
Photo 2 of 3 : UCIP_SP_2018_51286_24005.jpg

Concrete headwall and pipe at LS toe.

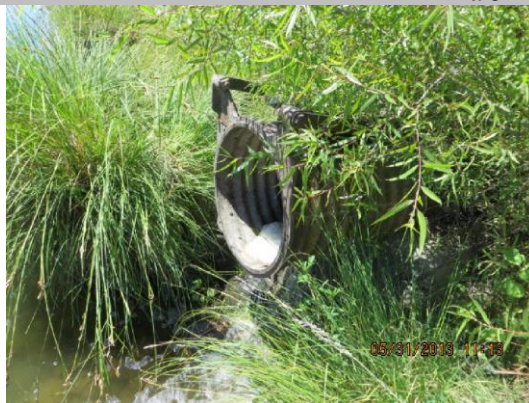
Photo 3 of 3 : UCIP_SP_2018_51286_24004.jpg

Pipe and flapgate at WS toe.

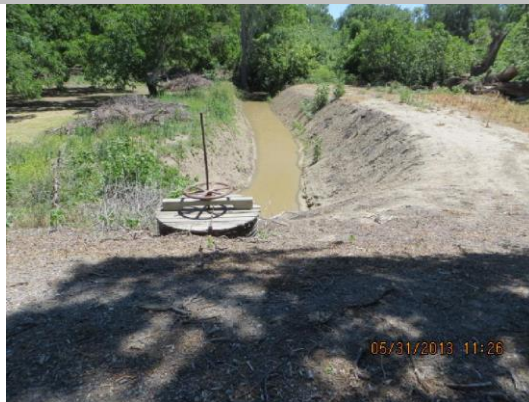
Photo 2 of 3 : UCIP_SP_2018_14565_24008.jpg

Slide gate in 60-inch CMP riser on WS slope.

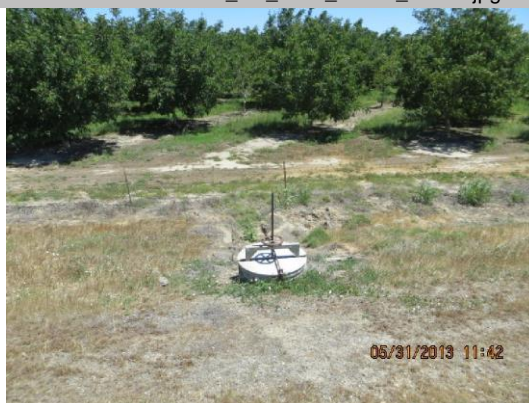
Photo 2 of 3 : UCIP_SP_2018_14566_24012.jpg

Slide gate in 36-inch CMP riser on WS slope.

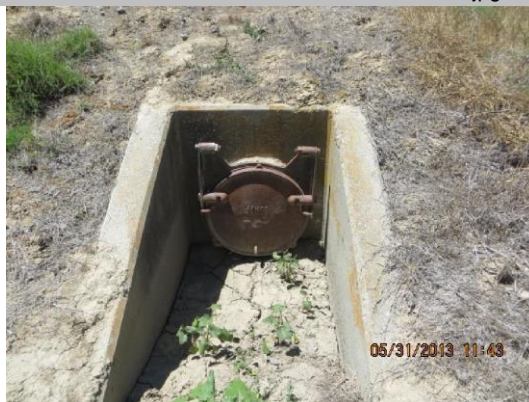
Photo 3 of 3 : UCIP_SP_2018_14566_24011.jpg

Concrete headwall and flapgate on WS toe

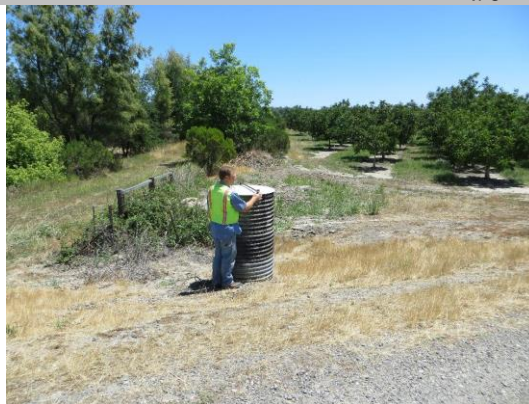
Photo 2 of 3 : UCIP_SP_2018_14567_24016.jpg

Slide gate in CMP riser on WS toe.

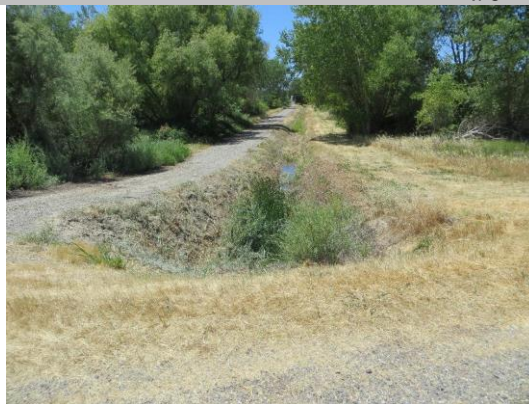
Drainage channel on LS toe.

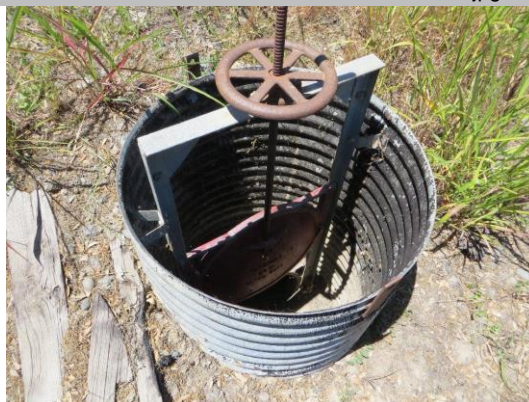
Photo 2 of 3 : UCIP_SP_2018_14570_24028.jpg

Slidegate in 36-inch CMP riser on WS slope.

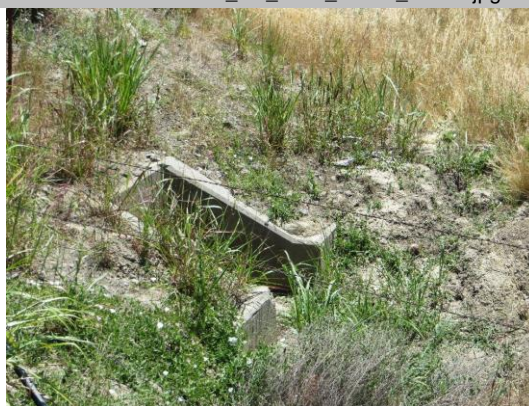
Photo 3 of 3 : UCIP_SP_2018_14570_24027.jpg

U-shaped concrete headwall on LS toe.
